**DISSESTO IDROGEOLOGICO NELL'ARCO ALPINO E PREALPINO:  
previsione, prevenzione e gestione dell' emergenza**

**MILANO  
28 Settembre 2018**

# IL MONITORAGGIO DELLA FRANA DEL GALLIVAGGIO IN VALCHIAVENNA (SO)

*a cura di:* **Dott. Geol. Luca Dei Cas**  
**ARPA - U.O. Centro Monitoraggio Geologico**

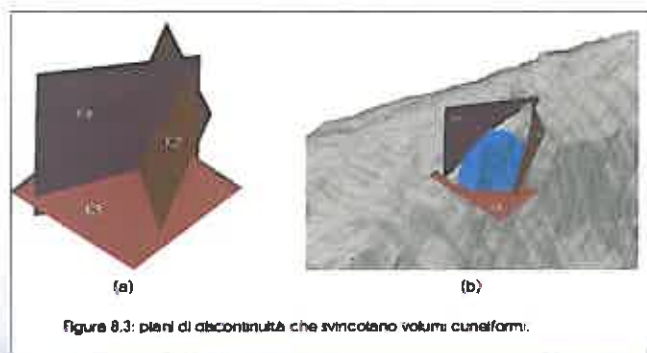
Figure 8.3: piani di discontinuità che svincolano volumi cuneiformi.

The **discontinuity sets**, inside the rock sub vertical cliff, **are very persistent**; their orientation cause rock block instability as you can see on the lateral image.

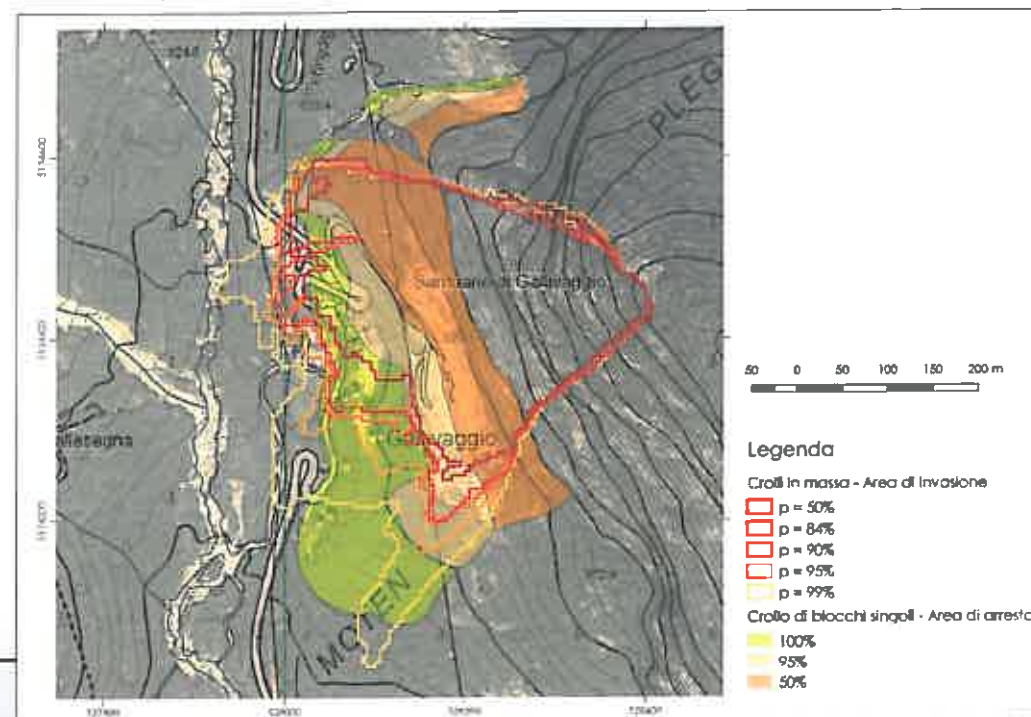
## 2017: GEOTECHNICAL MODEL

In 2017, a study called “**Geotechnical model and discern thresholds of trigger for the Gallivaggio landslide**” showed us different manifestations of rock mass failure.

The different colours lines represent the **area boundary where the landslide could arrive** with changeable probability (function of historical events printed on bibliography).

Most of the analysis showed that the infrastructure and cultural heritage (road and Sanctuary) are threatened (the rock mass failure could impact them)

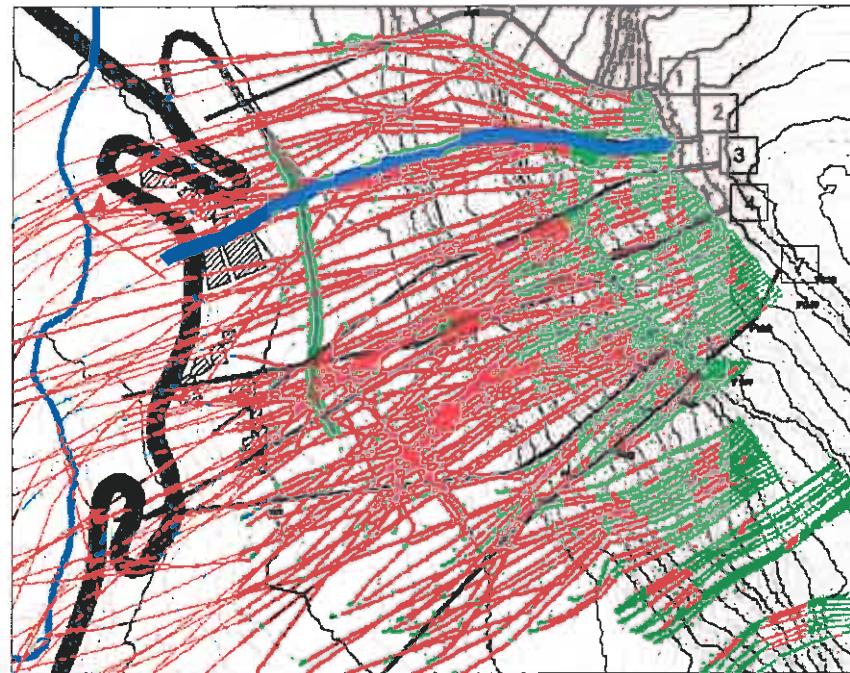
## SINGLE ROCK BLOCK FALLS: JUMP OVER BARRIERS

In the same study, quite an amount of simulation of single rock block falls, (from the upper part of the rock wall) **show us** that from 2% to 7% of these falls would jump over the long embankment and the flexible barriers.

Especially in section 2 the single rock blocks (22%) could arrive on the church or on the road and restaurant !! This situation is **impossible to predict** with monitoring network

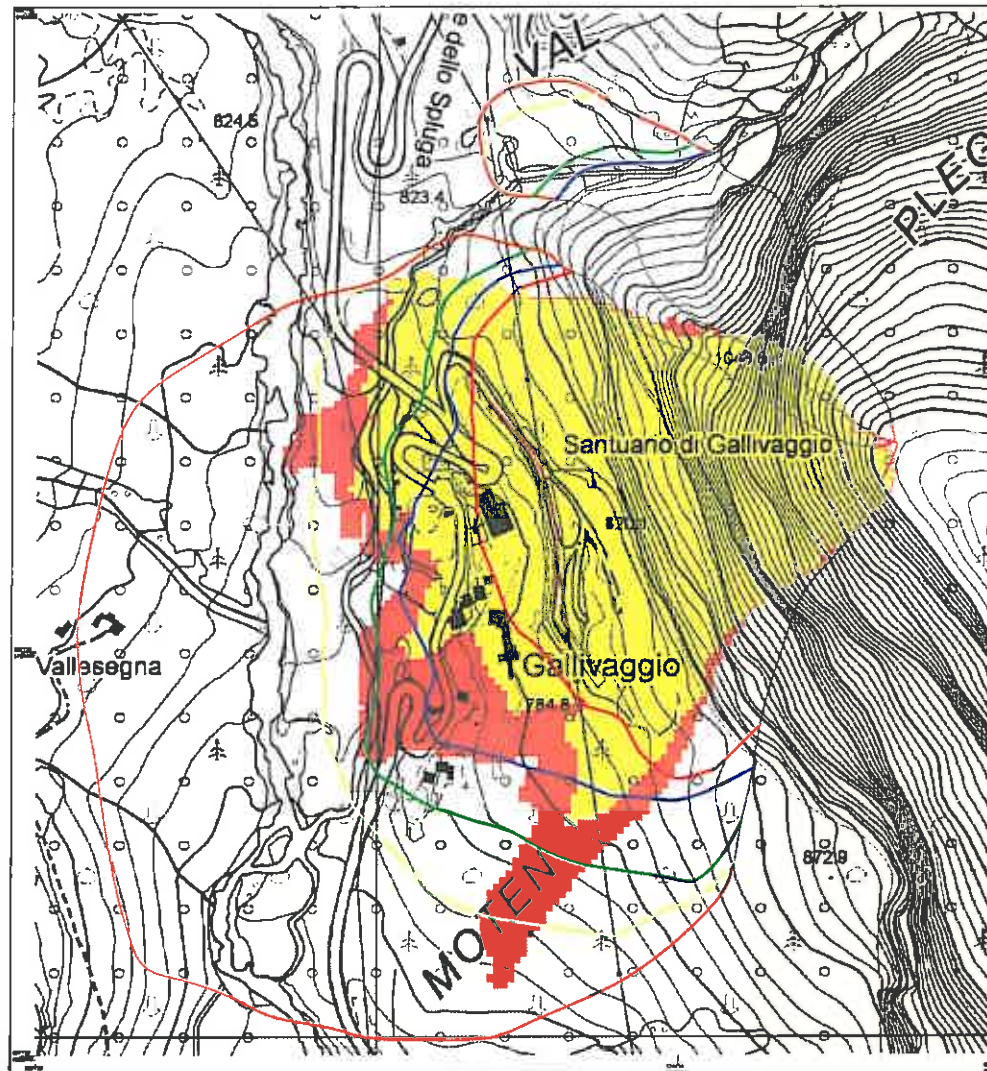
## ROCK MASS FAILURE

**Good performance of geotechnical modelling** : the scenarios of rock mass failure and single rock block failure had a good realistic overlapping.

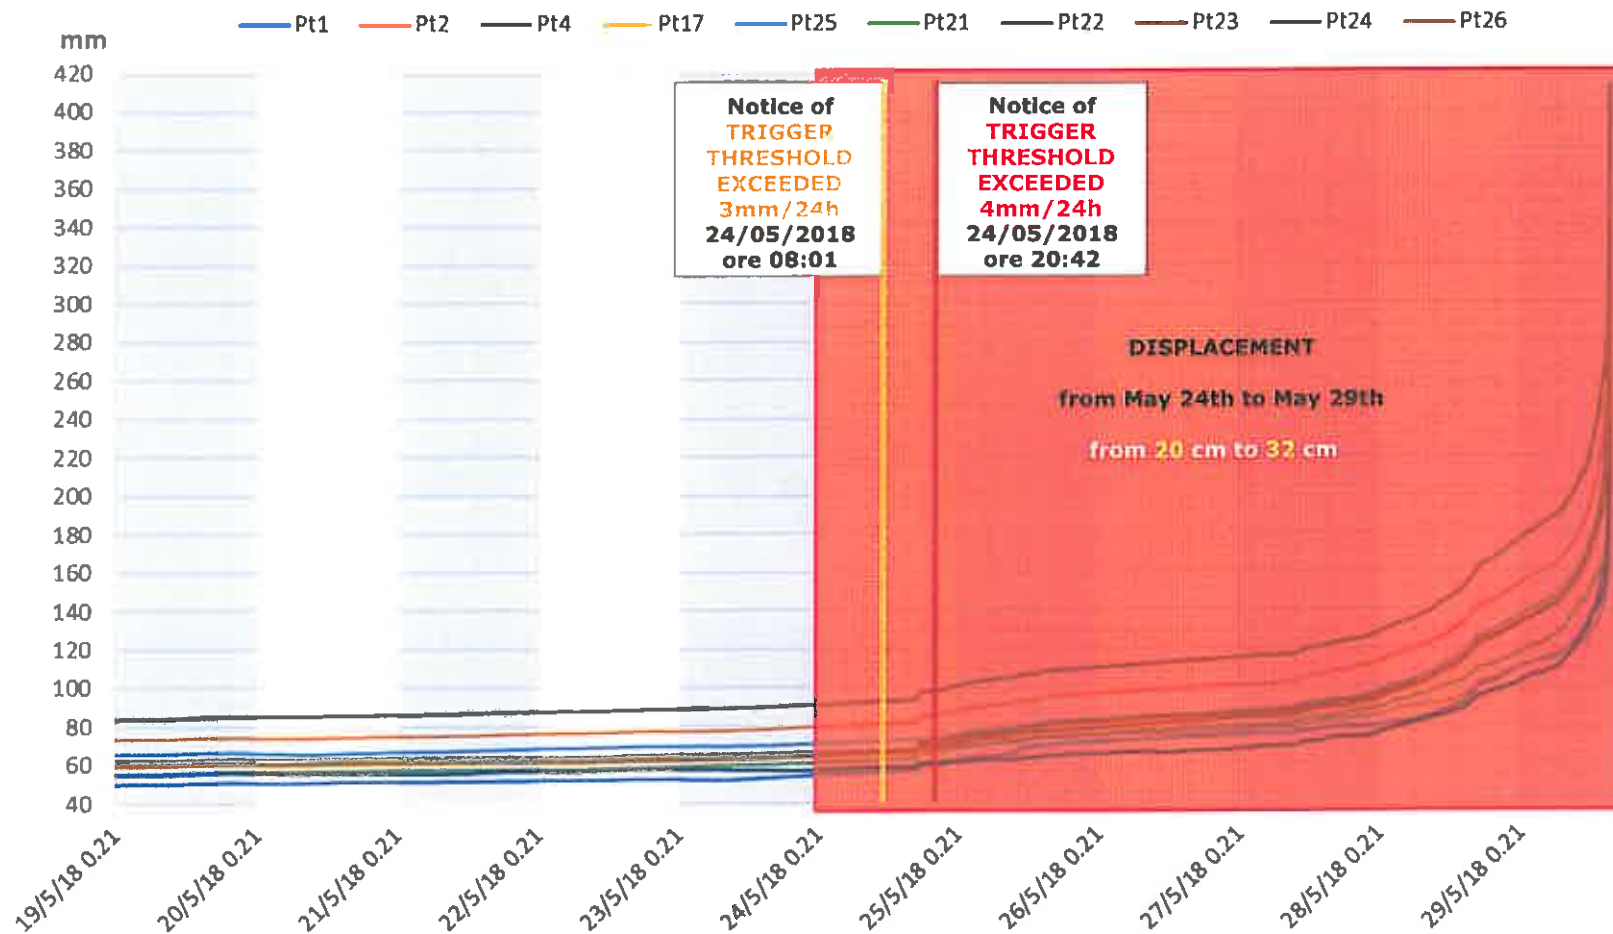
### Gallivaggio Radar points Displacements from May 19th to May 29th

Facendo seguito a quanto precedentemente comunicato si osservano nelle ultime 24 ore velocità dei punti monitorati in ulteriore aumento, con valori che hanno raggiunto un massimo di 107.2 mm/24h, con velocità orarie fra le 15 e le 16 di oggi di circa 2 cm/h. Valori così elevati non erano finora stati osservati sull'ammasso, ed il trend di continua accelerazione indica una situazione di estrema pericolosità ormai prossima al collasso.

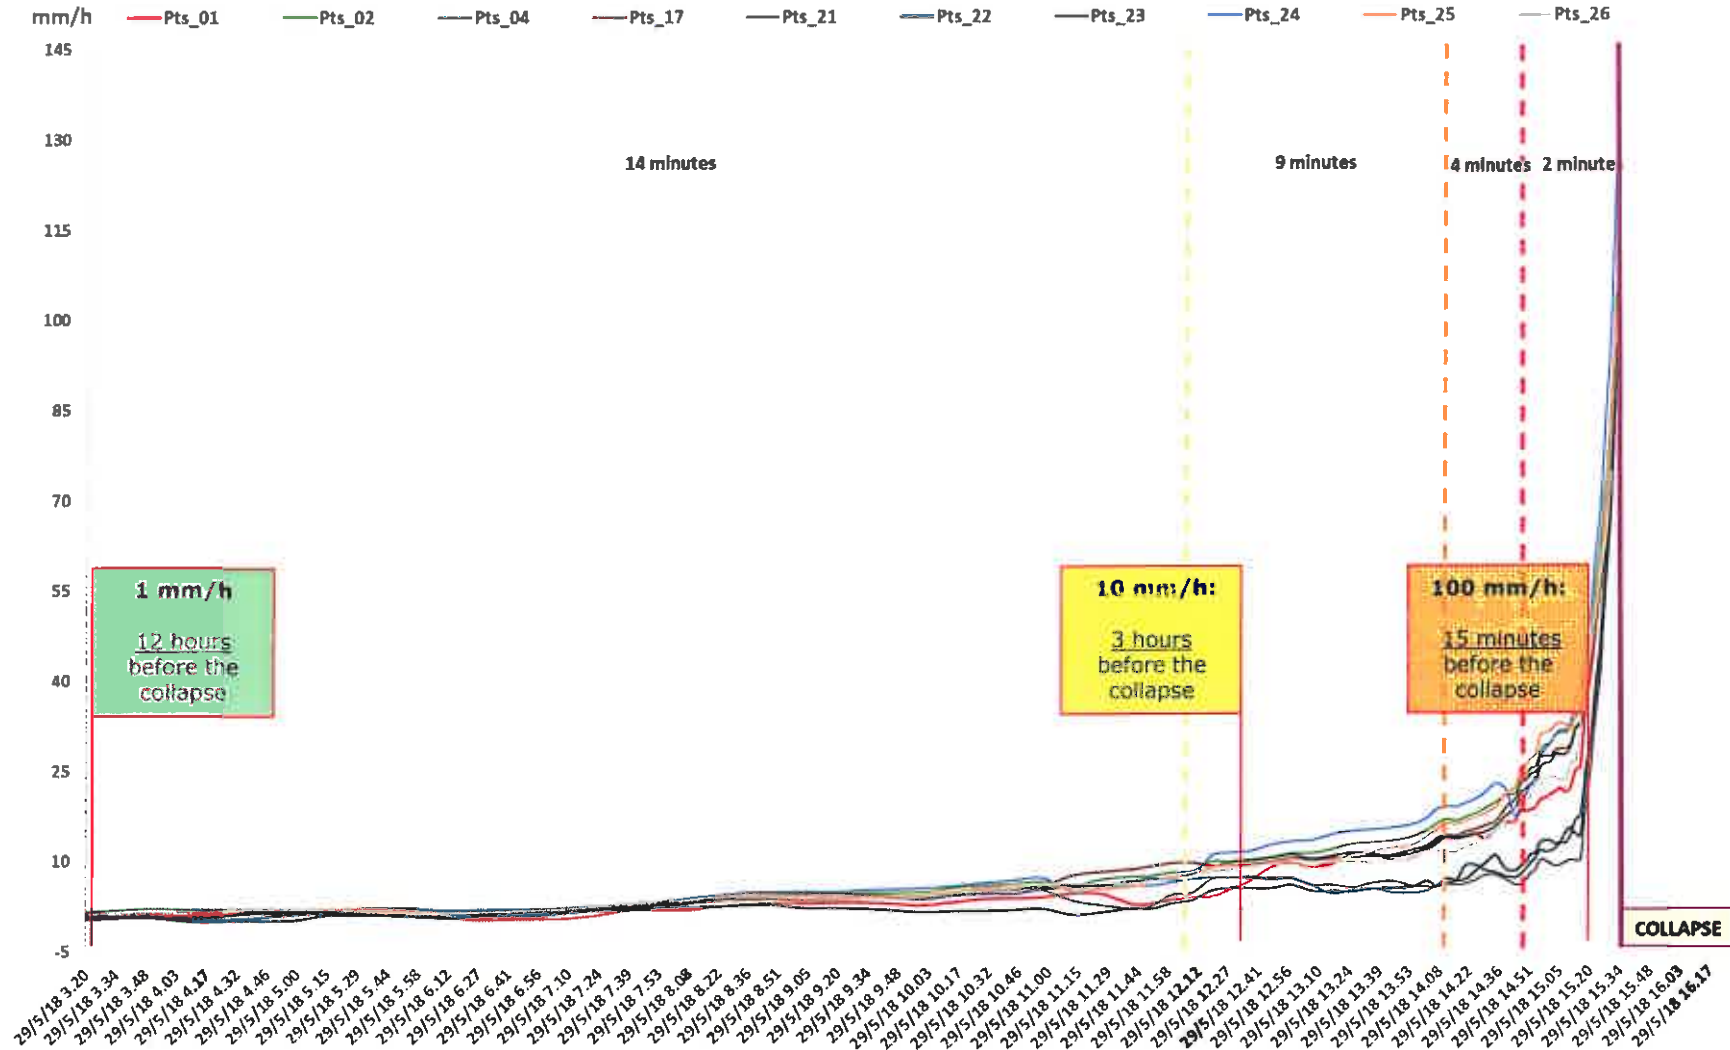
Gallivaggio radar points - velocity hourly (last 12 hours before the collapse )

**The collection of important data values**: the collection of data values, from the start of acceleration to the time of rock mass failure, permitted us to have all acceleration data values (0,1 mm/h 6 day from failure, 1 mm/h 40 hour from failure, 10 mm/h 3 hour from failure, 100 mm/h 15 minutes before failure).
